REPORT OF UPDATE ENGINEERING GEOLOGIC STUDY

PROPOSED CUSTOM SINGLE-FAMILY RESIDENTIAL DEVELOPMENT

**1420 BELLA DRIVE
BEVERLY HILLS AREA, CITY OF LOS ANGELES, CALIFORNIA**

Project No.: LP1174

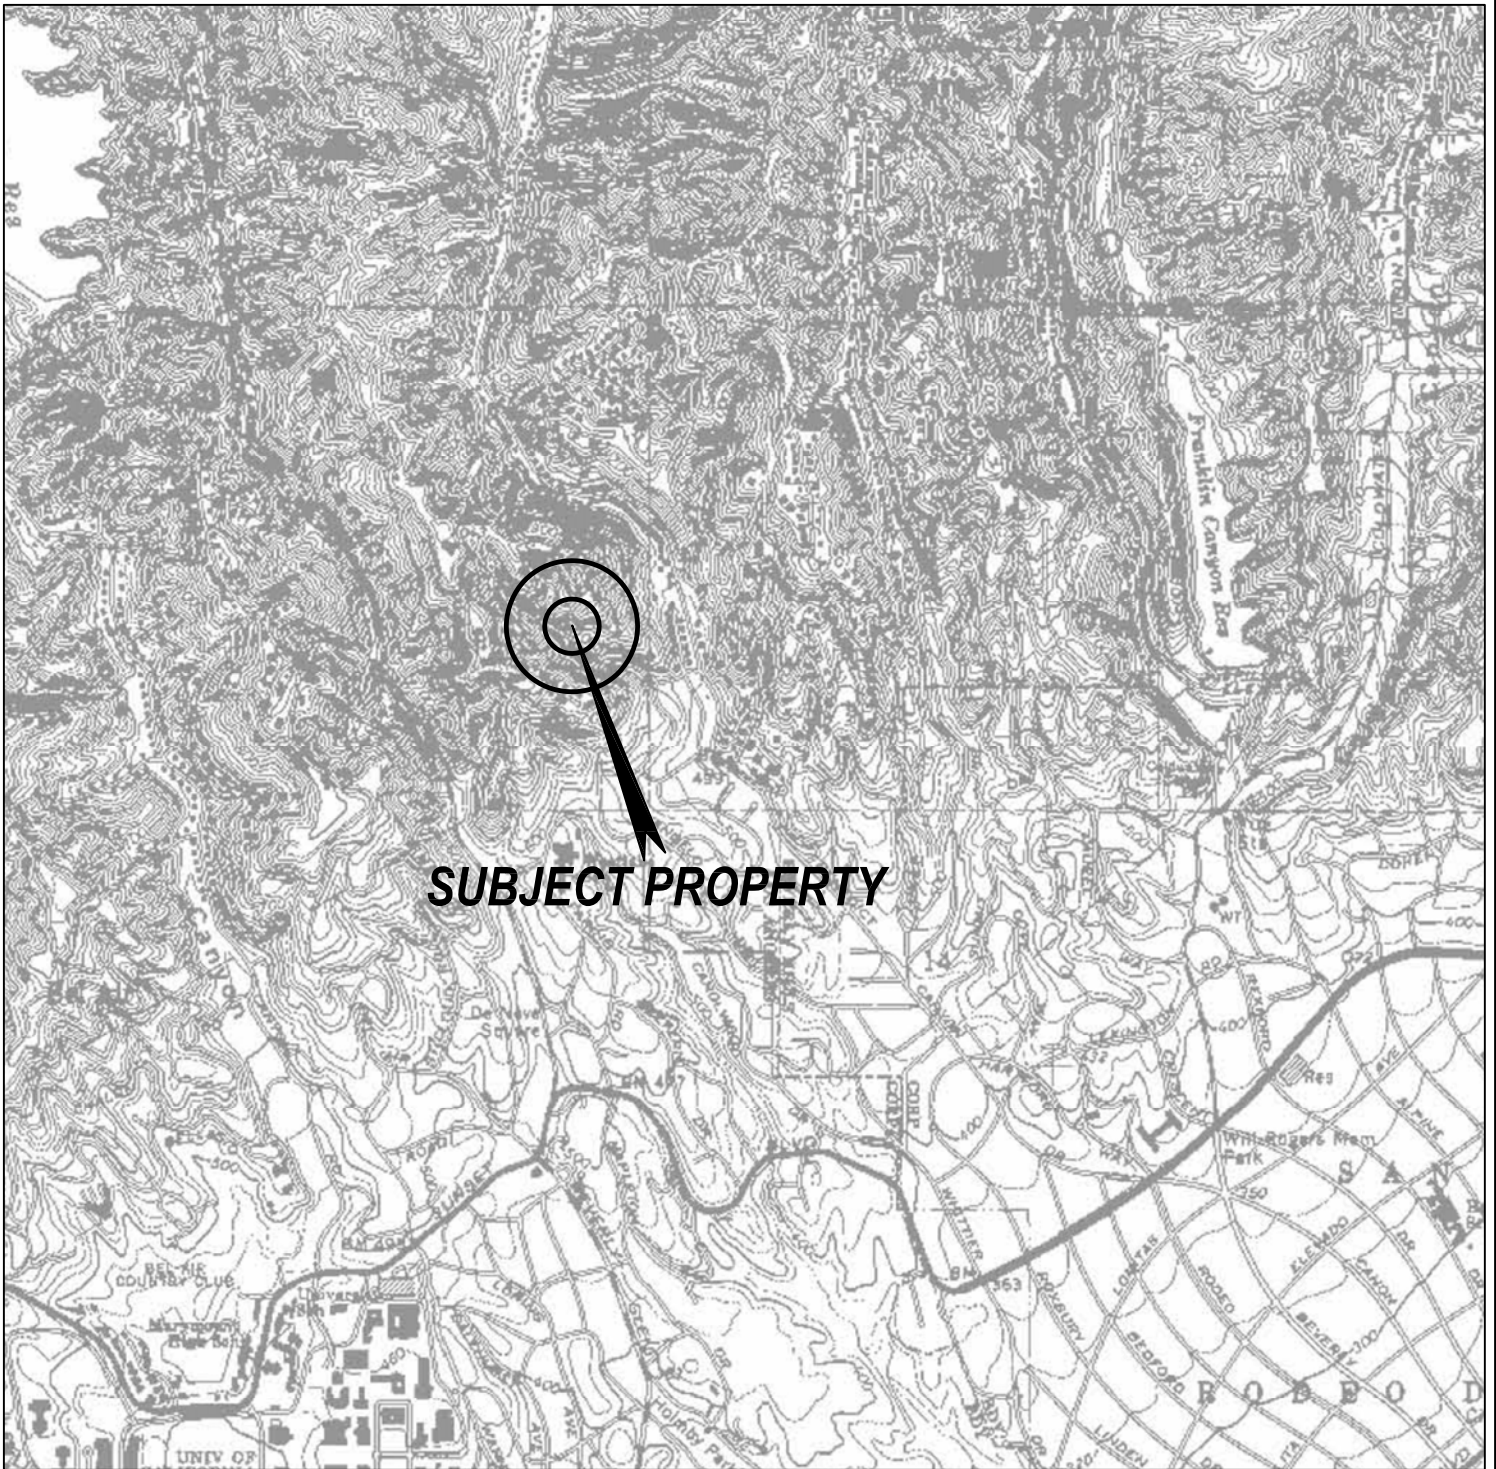
FIGURE 6

EARTHQUAKE FAULT ZONE MAP

REFERENCE: EARTHQUAKE FAULT ZONE MAP OF THE BEVERLY HILLS QUADRANGLE, LOS ANGELES COUNTY, CA., C.D.M.G., 1986

The subject property is not located within a California Earthquake Fault Zone (see Figure 6) and no known potentially active or active faults cross the site. However, as previously discussed in this report, regional geologic mapping by the City of Los Angeles (1960-70) indicates that north/south-trending shear zones and faults traverse portions of the subject property. In addition, an east/west-trending fault is mapped in close proximity to the northern margin of the site (see Figure 4). During our recent geologic field mapping of the subject property and adjacent area, conclusive evidence as to the presence or absence of these faults was not apparent. Regardless, faults are common in this area of the Santa Monica Mountains and based on the findings of our update engineering geologic study, the local faults mapped by the City of Los Angeles (if indeed present) are not interpreted to be potentially active or active tectonic features.

Based on the findings of our update engineering geologic study, the subject property is not located within a California Earthquake Fault Zone (see Figure 6) and no known potentially active or active faults traverse the site. Thus, LP considers the possibility of surface fault rupture within the subject property to be extremely low.
